Manhole Inspection Summary

Manhole # S19MM_004MH

Location Address: **2221 PULASKI-PAYSON**

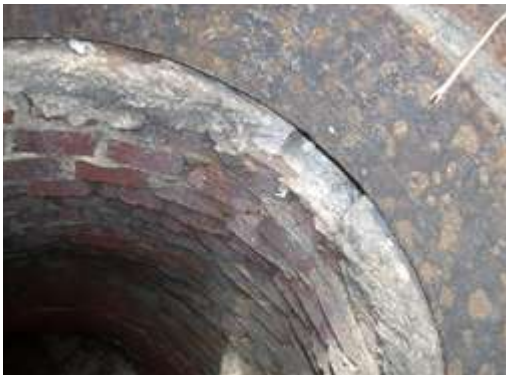
Defect 1

Condition: ☐ Sound ☐ Cracked ☐ Root Intrusion ☐ Loose Brick ☒ **Deteriorated**

DETERIORATION OF CHIMNEY
(MISSING)

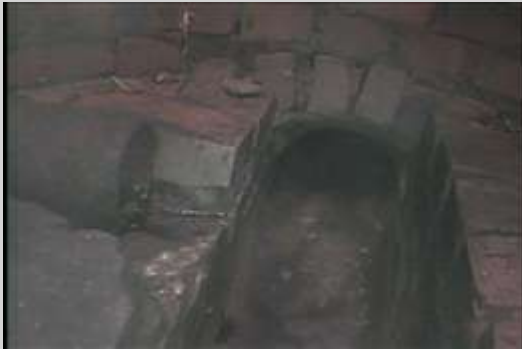
12 O'Clock Outflow

Pipe Height: **8.4** (in.) Rod and Bar (Angled)
Pipe Material: **Clay** ☐ Pipe Lined
Invert Depth: **8.52** (ft.) Flow Characteristics: **Slow**
Deposits: ☐ None ☐ Mud ☐ Sludge ☒ **Debris** ☐ Grease
Silt Depth: **2** (in.) Deposits Extent: **Light**
Infiltration: **None** Pipe Seal Cond: **Sound**

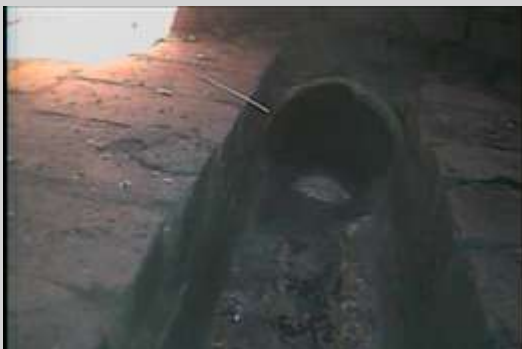
6 O'Clock Inflow

Pipe Height: **8.4** (in.) Rod and Bar (Angled)
Pipe Material: **Clay** ☐ Pipe Lined
Invert Depth: **8.41** (ft.) Flow Characteristics: **Slow**
Deposits: ☐ None ☐ Mud ☐ Sludge ☒ **Debris** ☐ Grease
Silt Depth: **1** (in.) Deposits Extent: **Light**
Infiltration: **None** Pipe Seal Cond: **Sound**

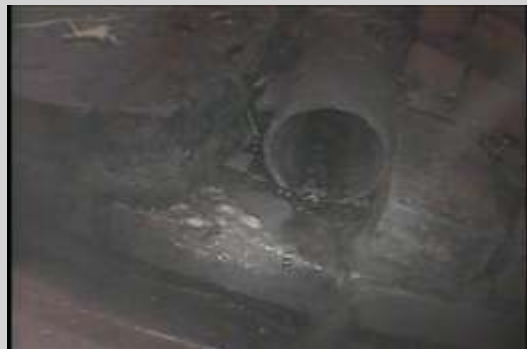
9 O'Clock Inflow

Pipe Height: **4.8** (in.) Rod and Bar (Angled)

Pipe Material: **DIP/CI** ☐ Pipe Lined

Invert Depth: **7.71** (ft.) Flow Characteristics: **None**

Deposits: ☒ None ☐ Mud ☐ Sludge ☐ Debris ☐ Grease

Infiltration: **None**

Pipe Seal Cond: **Sound**
